Reference: A-111222-01-16

# Legionella Risk Assessment

Address: **Flat 2  
Wingate Street  
NW10 2ED**

Survey Date: **02/06/2015**

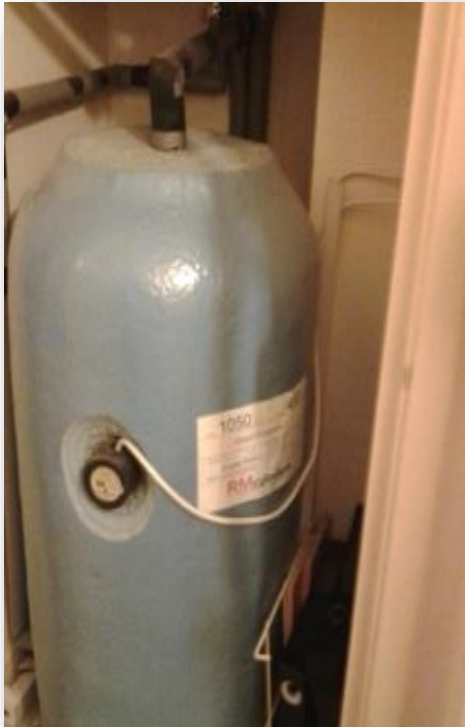
### HW Cylinder

| Flow temperature | 55 |
| Return Temperature | 50 |

| Action | Priority |
|---|---|
| No remedial action required | |

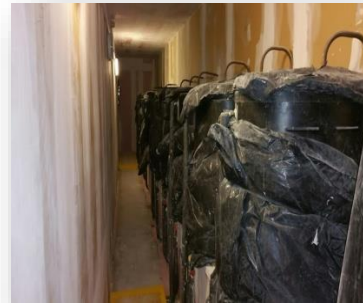
### CWST In Loft Space

| Close fitting Lid | No |
| Lid vent | No |
| Overflow screen | No |
| Scale | High |
| Sediment | Heavy |

| Action | Priority |
|--|---|
| Upgrade CWST to comply with requirements of L8 and the current Water Regulations, i.e install lid vent and overflow screen | High Priority |
| Investigate open vent discharging to CWST | High Priority |
| Clean and disinfect all CWST | High Priority |

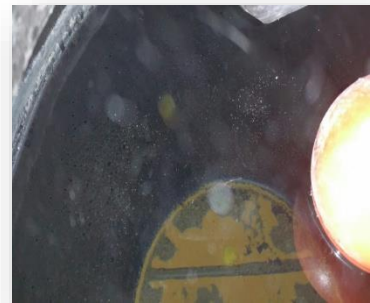
### CWST Sediment For Flat 2
